Addendum to Seller's Disclosure Notice for 4904 Balcones Dr., Austin, TX 78731

Report Identification: 4904 Balcones Dr. Austin, TX 78731

### REPAIR SUMMARY EXTERIOR:

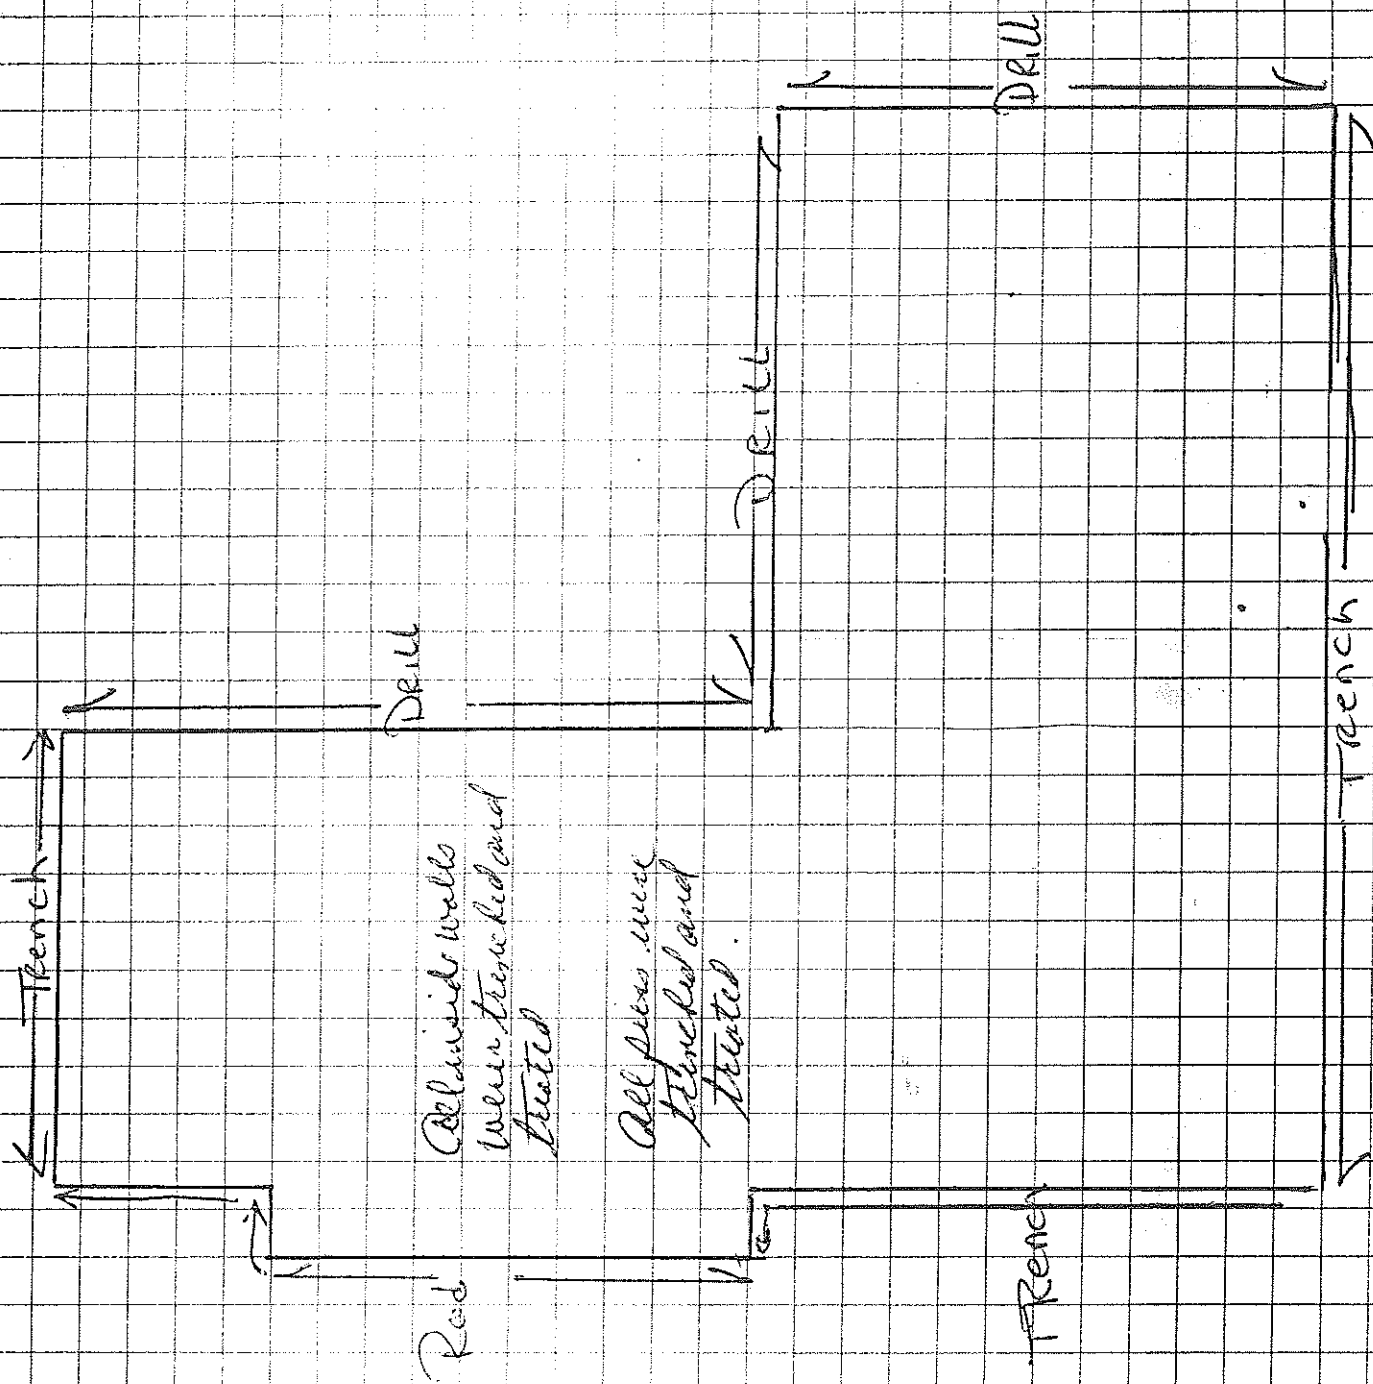
Thomas First Property  
4904 Bolcoms  
Austin Tex.

Previous termite damage/treatment - 8/91 Hill Country Pest Control treated entire property (see diagram). Inspected and renewed contract until 6/98. Unable to get them to come back when I reported problem. Wall in den next to hall only evidence of problem. Paneling & sheetrock removed; replaced and repainted. 4/99 ABC Pest Control did treatment, installed Sentricon System and have checked property on regular routine to ensure no return of termites.
